## **Water Quality Report**

# DART+ West, Maynooth- Kilcock, Co. Kildare

Water Quality Report

10 November 2021

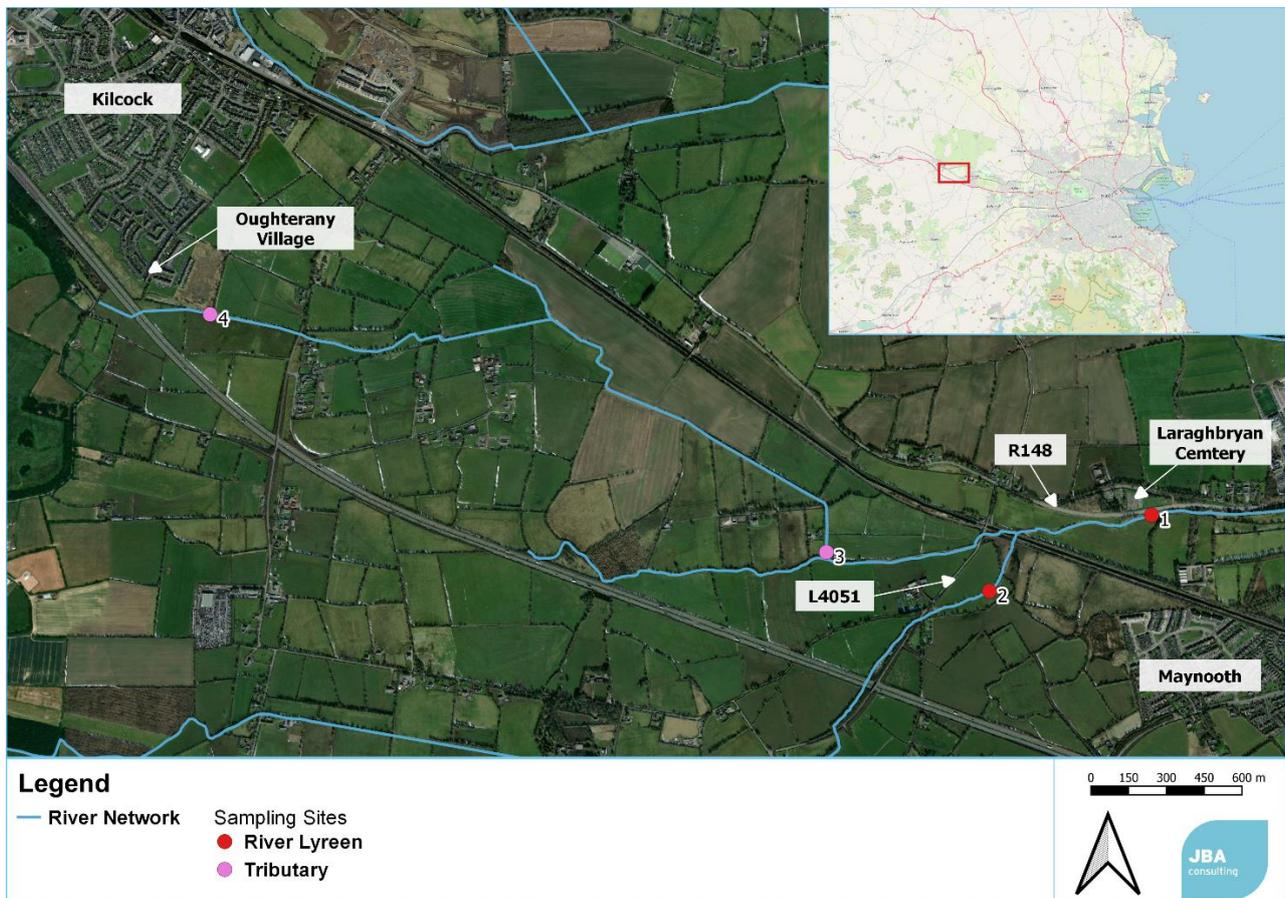
Figure 1-1: Surface water and invertebrate kick-sampling site locations

A total of four surface water and invertebrate kick-sampling sites were located within the main channel of the River Lyreen (adjacent to the R148 and Laraghbryan Cemetery; and east of the L5041) and one of its tributaries (west of the L4051 in the Ballycurraghan area; and south-east of Oughterany Village, Kilcock). Figure 1-1 displays the sampling site locations below.

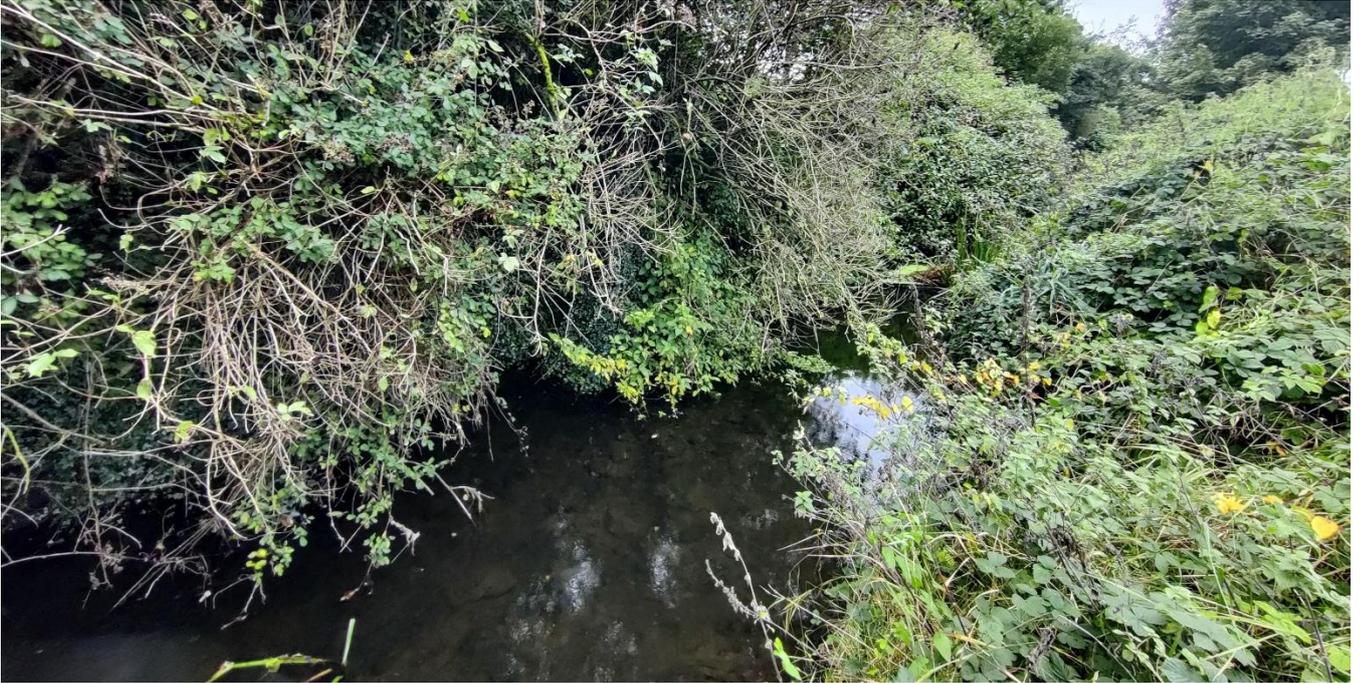
Figure 2-1: River Lyreen main channel sampling site

The riverine characteristics of these sampling locations varied from a small river with riffle and pool features, mixed substrate and in-stream vegetation growth (see Figure 2-1), to agricultural ditches, lacking in-stream vegetation, physical variation in substrate and riffle and pool features (see Figure 2-2).
