**Appendix A21.5
Broome Bridge -
Architectural Heritage
Impact Assessment**

DART+ West

Proposed works at Broome Bridge, Cabra, Co. Dublin

Architectural Heritage Impact Assessment

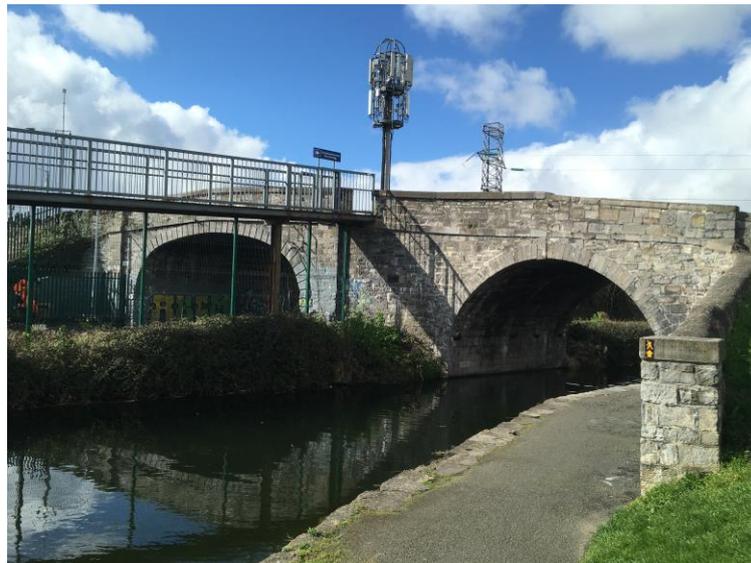
The older portion of the bridge spanning over the canal is characterised by a lower semi-circular arch with keystone. The later extension of the bridge over the railway line is characterised by a higher elliptical arch.

Figure 1 – East elevation of Broome Bridge showing both arches with the railway on the left hand side and canal on the right hand side.

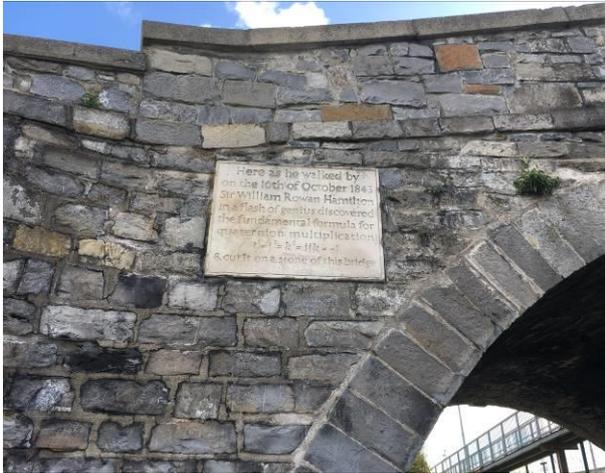
The spandrels of the canal are faced with squared limestone laid in courses. The west face of the canal bridge contains a plaque commemorating a significant mathematical equation carved into the bridge by astronomer Sir William Rowan Hamilton in 1843.

Figure 2 – Canal spandrel with squared limestone and commemorative plaque for Sir Hamilton.

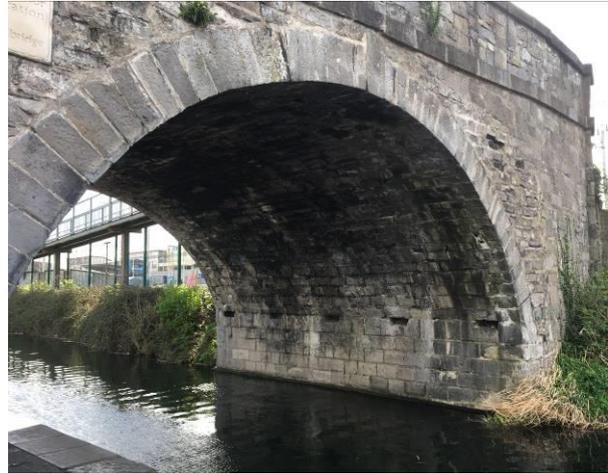
Figure 3 – West spandrel of bridge and canal arch.

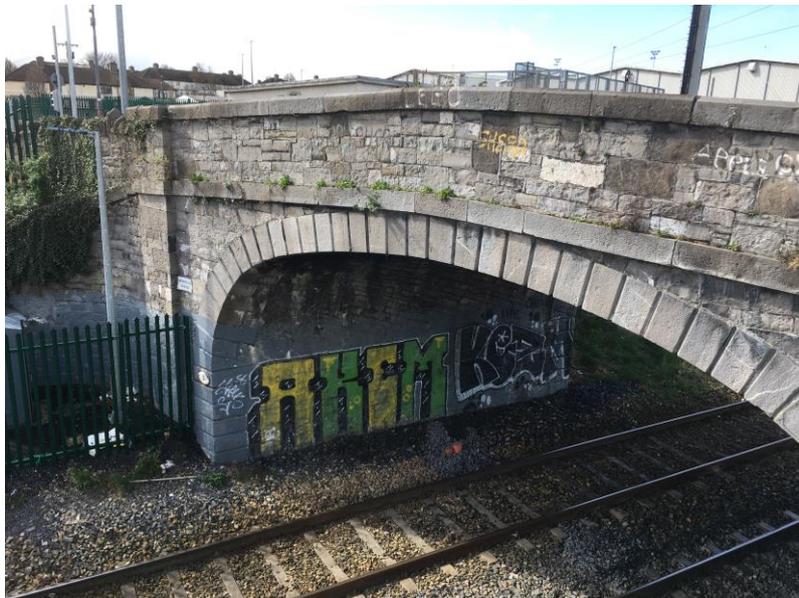
The railway arch is elliptical in shape, and the vault of the arch is impressively skewed due to the angle of construction necessitated by the differing angle of Broombridge road. The railway arch is decorated by an arch ring of voussoirs, without a keystone, and flanked either side by two engaged piers. Quoins below the arch spring extend to the piers on either side.

Figure 4 – Railway arch showing voussoirs of arch ring, string course, engaged pier and a wing wall curving away to the east (left hand side).

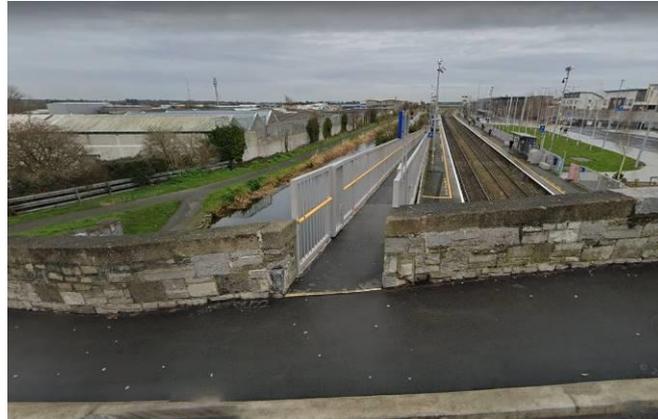
The canal section of the bridge contains the oldest coping stones. The parapet has a modern breach on the east side between the arches, providing pedestrian access from the bridge to the train platform below.

Figure 5 – Breach in east parapet wall.

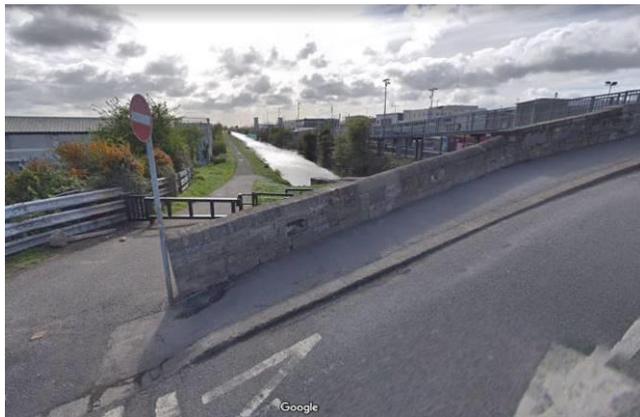
On the north end of the bridge, the parapets meet directly with a lower section of wall, which has been reconstructed in a mixture of stone and blockwork. The wall is topped with a combination of rounded concrete flaunchings and block coping stones laid on edge. It continues parallel with the road before stopping short of the embankment paths down to the canal on the west and east sides.

Figure 6 – North east wall, showing reconstructed end and path to the canal on the left side.

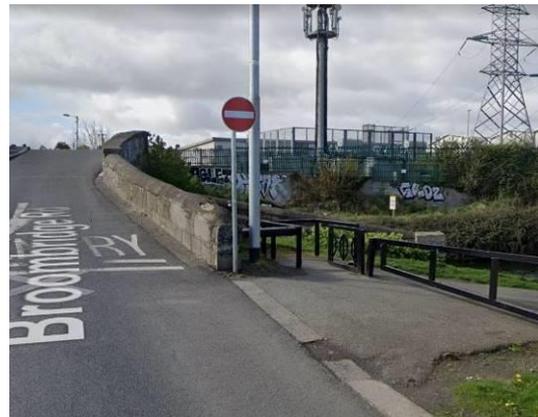
Figure 7 – North west wall and path to the canal on the right side.

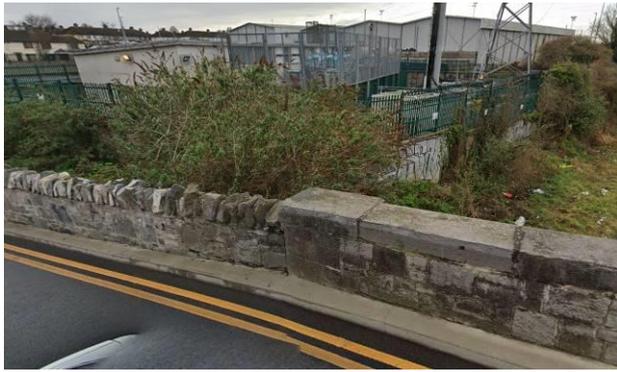
On the south end of the bridge its parapets continue parallel with the road to a point where random rubble limestone walls butt directly against the parapets and continue alongside the road at the same height. These are topped with vertically laid limestone slabs. On the east side of the road, the wall appears to be historic. On the west, the wall appears to have been reconstructed recently to match the style of the original.

Figure 8 – South west parapet end and recently reconstructed random rubble limestone wall.

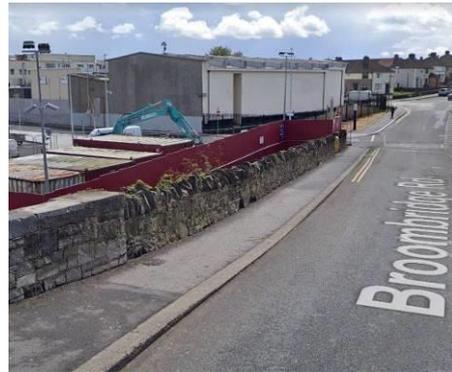
Figure 9 – South east parapet end and historic random rubble limestone wall.

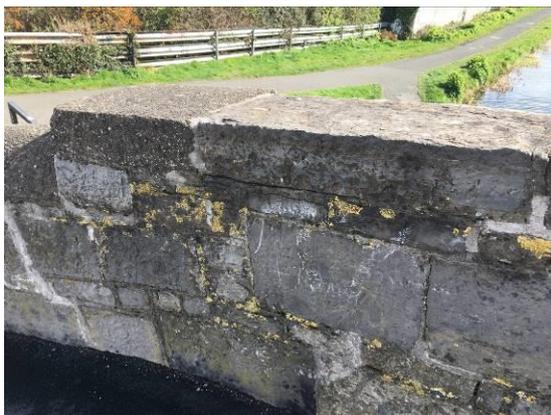
The east parapet wall contains various stonework styles and coping types. At the north end, it is constructed in coursed squared limestone, with courses of varying heights. The coursing angle follows the rise of the bridge. Apart from the concrete coping on the pier, this section is topped with large historic limestone copings. This continues up to the apex of the canal arch. From this point, the extension to the bridge for the railway line begins, and the rising angle of the parapet is carried through. Coping stones are then replaced with concrete slabs for a length where the breach in the parapet provides access to the pedestrian bridge. The parapet continues south with large historic limestone coping stones for the majority of the railway span before ending with a pier and a larger coping stone to cover.

Figure 10 – East parapet wall over canal with historic limestone copings.

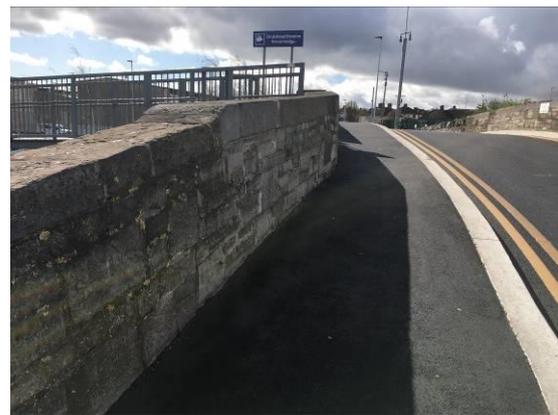
Figure 11 –View looking south over the bridge, with historic coping stones on the parapet.

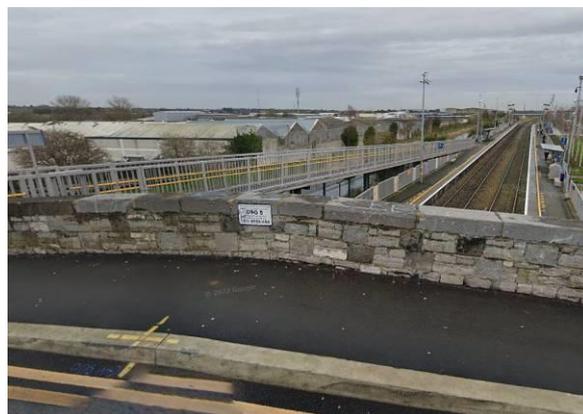
Figure 12 – East parapet and crown of bridge over railway line.

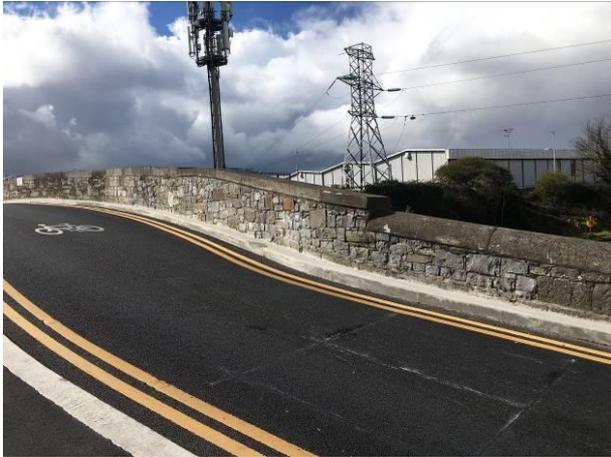
The west parapet wall also contains various stonework styles and coping types. At the north end it is constructed in randomly laid small sections of squared limestone. This section is topped with large limestone coping stones which are historic, up to the apex of the canal arch. From this point, the

extension to the bridge for the railway line begins, and the rising angle of the parapet is carried through with the copings. The parapet stonework changes in style and continues south with large historic limestone copings completing the parapet, for rest of the railway span. The parapet ends with a pier and a larger coping stone to cover.

Figure 13 – Oblique view of west parapet looking south showing step where the parapet meets the adjoining wall and differing stonework styles and copings.

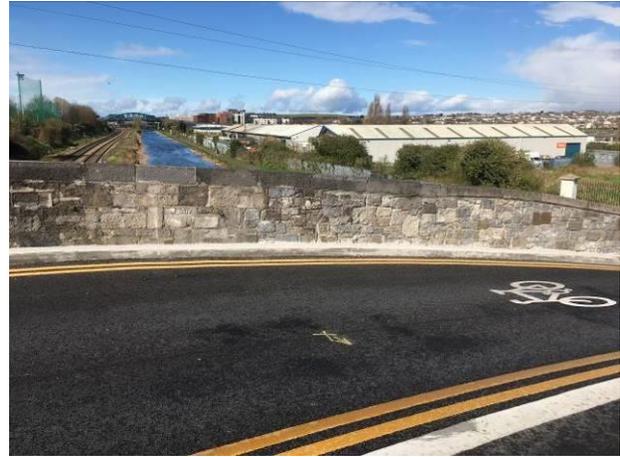
Figure 14 – West parapet showing section of parapet rebuilt.

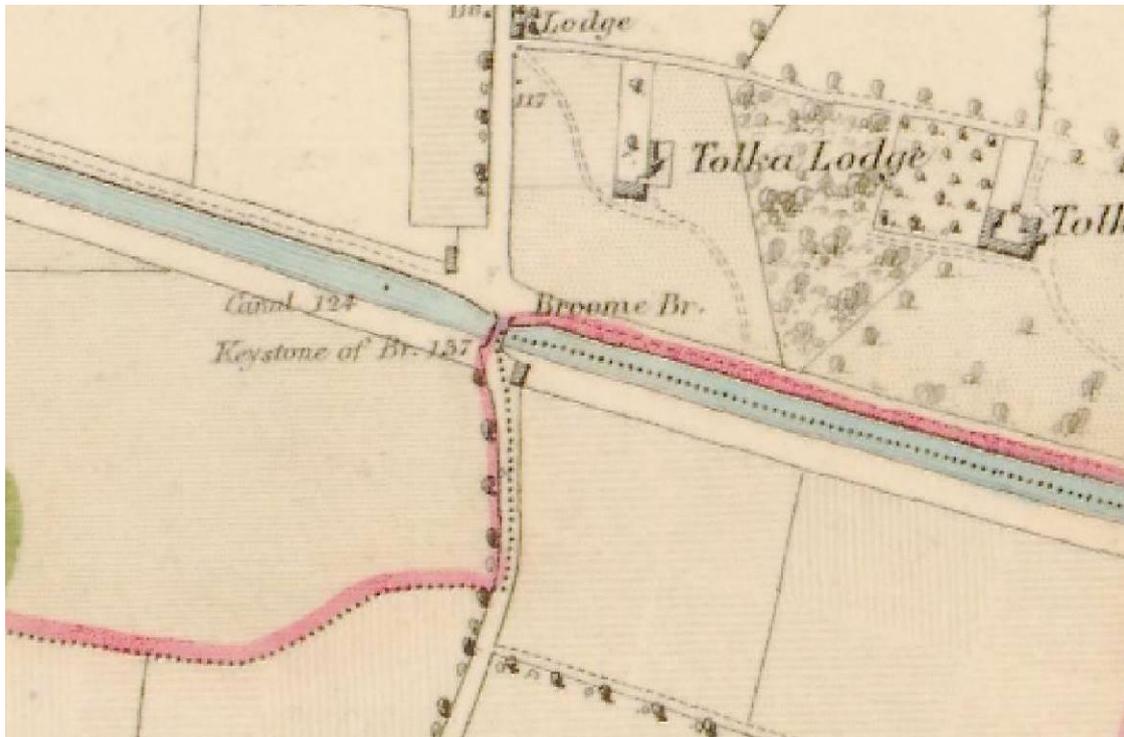
In the OS Map below, the railway line has not yet been constructed. A clearing north of the bridge is seen, possibly indicating access to the towpath at canal level. The construction of the bridge perpendicular to the canal is clearly shown. A small structure sits to the south of the bridge. The approach roads north and south are lined with trees on one side. The map also records the level of the canal and the keystone of the bridge.

Figure 15 – 6inch OSI Map 1829 - 1841 showing Broome Bridge crossing the Royal Canal.

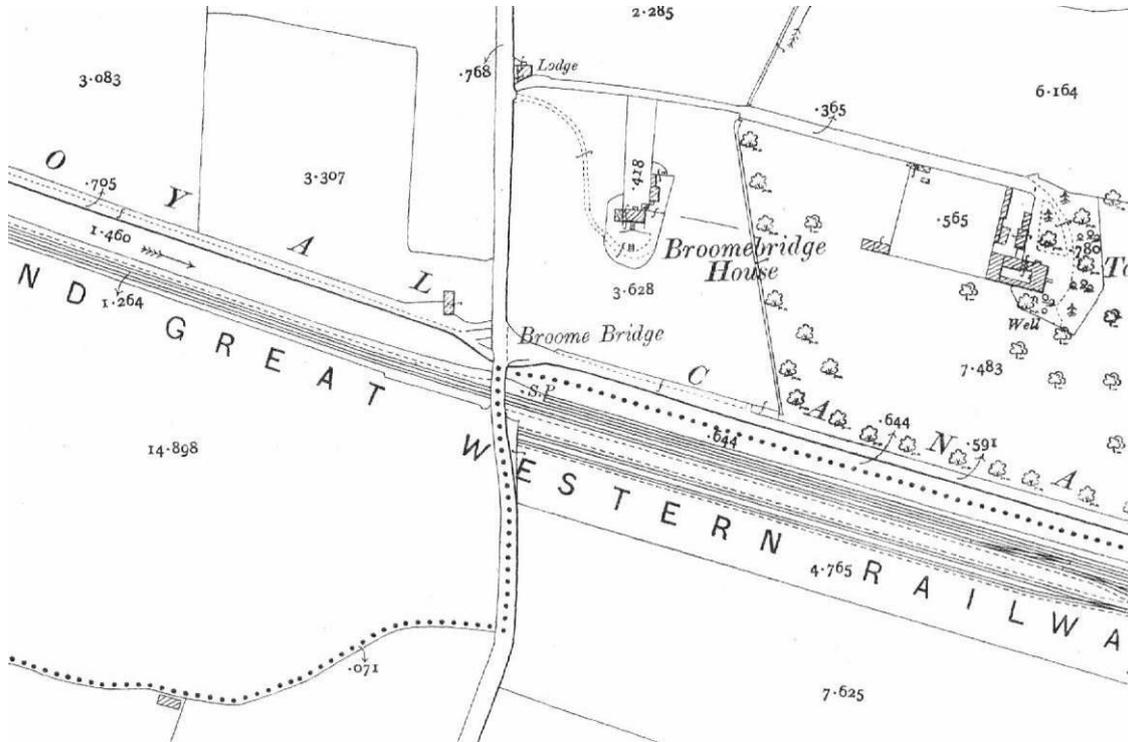
The 25inch OS Map (Figure 16) records the arrival of the railway line in Cabra and also documents Broome Bridge in context in greater detail. Ramped paths to the towpath at canal level are now clearly visible to the north of the bridge. The bridge is also now extended over the railway line. However, the angle of the bridge and its extension are not recorded. The paths to the north of the bridge indicate a route from the road down to the level of the canal. The towpath along the south of the canal is also visible along with train lines terminating to the south.

Figure 16 – 25inch OSI Map 1888-1913 showing the addition of the rail line and the extension to Broome Bridge.

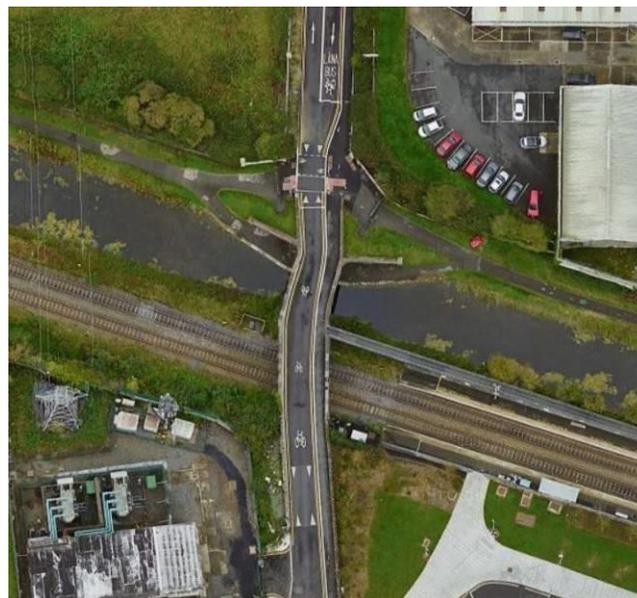
Figure 17 – Screenshot taken from Google Maps, 2022.

Google satellite imagery from 2022 shows Broome Bridge as it is today with the train station to the east. The pedestrian access to the canal from the north is clearly visible.

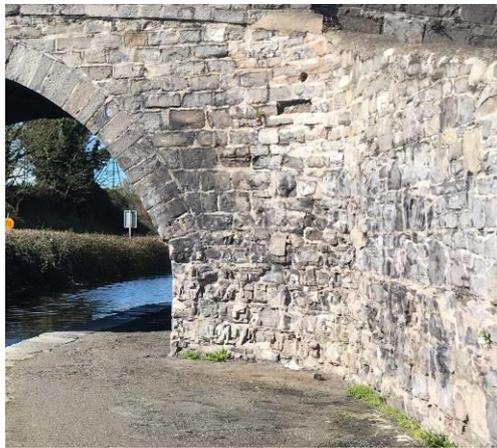
The stonework of the arches, buttresses and spandrels do not appear to have major structural issues. It was not possible to get access to many areas but no structural cracks were identified. The stonework on the face and the rising wall under the arches generally appears to be in good condition apart from a number of areas on the canal side where extensive weathering is visible. This is particularly evident on the north east face near the base of the arch. There are small pockets where the stone face has broken away, especially on the canal side, but this is not widespread. The smaller stonework forming the arches appears to be more weathered and there is some evidence of moisture penetration from the road deck above. The railway side could not be properly inspected due to access constraints but it is clear that all the stone has been painted at low level, presumably to cover earlier graffiti. There appears to be a number of phases of pointing on the bridge, some of which is likely to be an inappropriate cement mortar. This pointing has been washed out or has fallen away in many areas, predominantly beneath the arches and on the spandrels of the canal span. The joints on the railway side are tighter but there is evidence of localised pointing loss there as well.

Figure 18 – Weathered facing stone visible, especially below the spring of the arch.

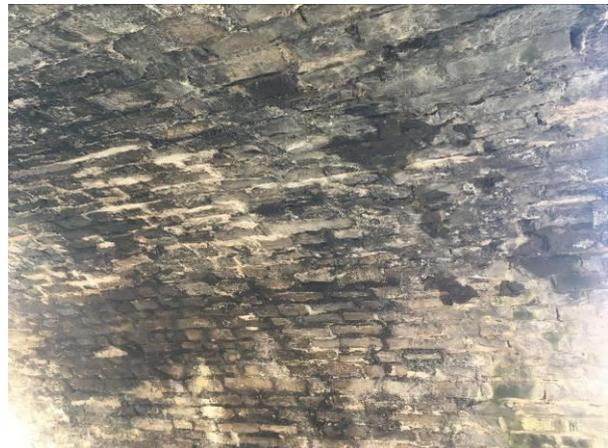
Figure 19 – Condition of canal arch stonework.

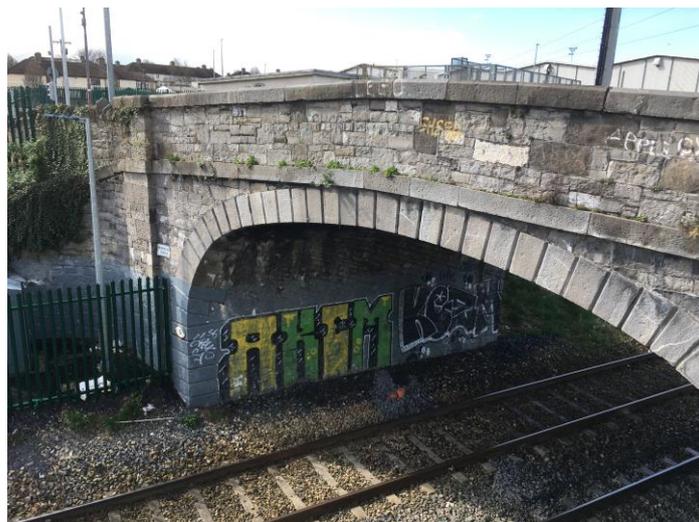
Figure 20 – Graffiti under railway arch.

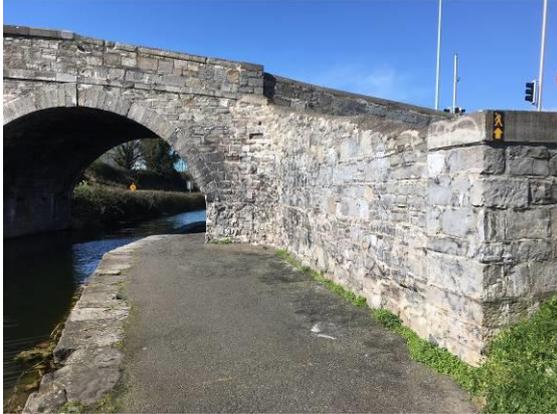
There are three wing walls on the bridge and their condition varies. The wall to the north west is in fair condition with slightly increased weathering present on stone at low level. The original copings have been lost and replaced with concrete and a section of the wall is covered in graffiti. The stonework on the north east wall has weathered considerably in the area that adjoins the bridge face. Like the north west side,

Figure 21 – North east wing wall.

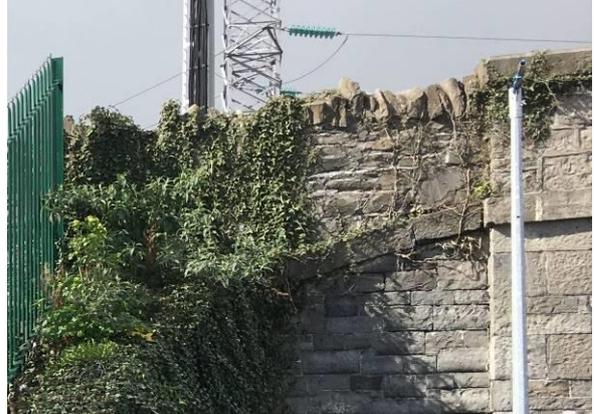
the original copings have been lost and replaced with concrete. It was not possible to inspect the south east wing wall due to the limited access and extent of growth over the wall during the inspection. It looks like the original copings are still in place and the stonework appears to be in fair condition from a distance. The painting of stonework below the arch extends onto this wing. The walls have been repointed a number of times, some more successfully than others. This pointing is failing in localised areas.

Figure 22 – Original copings visible to south east wing wall.

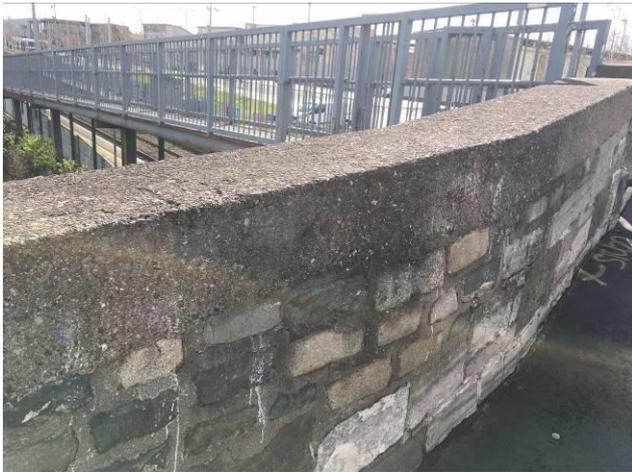
The parapet stonework appears to be sound but there are a number of phases of rebuilding visible. It is difficult to get close to the external face of the parapets but from a distance they appear to be in fair condition with the exception of localised areas of vegetation. The ramp to the platform connects to the bridge through the parapet and these junctions are poorly executed. Original stone on the parapet was broken away to create the junction. There are a variety of coping stones on the bridge including the original canal bridge copings, original railway arch copings and several versions of replacement concrete copings. The concrete copings have hairline cracks in places and localised repairs have been carried out. There are a variety of pointing styles on the bridge including recessed pointing on the newly built stone and the pointing is buttered over the stone on the older sections. Both of these styles are inappropriate for this historic bridge and all cement mortars are detrimental to the historic stonework.

Figure 23 – Poor condition of pointing & concrete copings.

Repair works will be required to the existing parapet before the proposed heightening works can take place. All joints will need to be examined and raked out where the existing mortar is lost or failing. Joints

will need to be repointed in a suitable lime mortar and protected until satisfactorily carbonated. These works must be carried out by a skilled mason with extensive experience with historic stonework. The existing connection for the ramp access to the platform is to remain in position and no alterations are proposed.

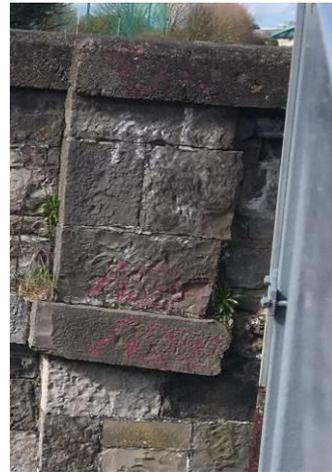
Figure 24 – Pier stone damaged.

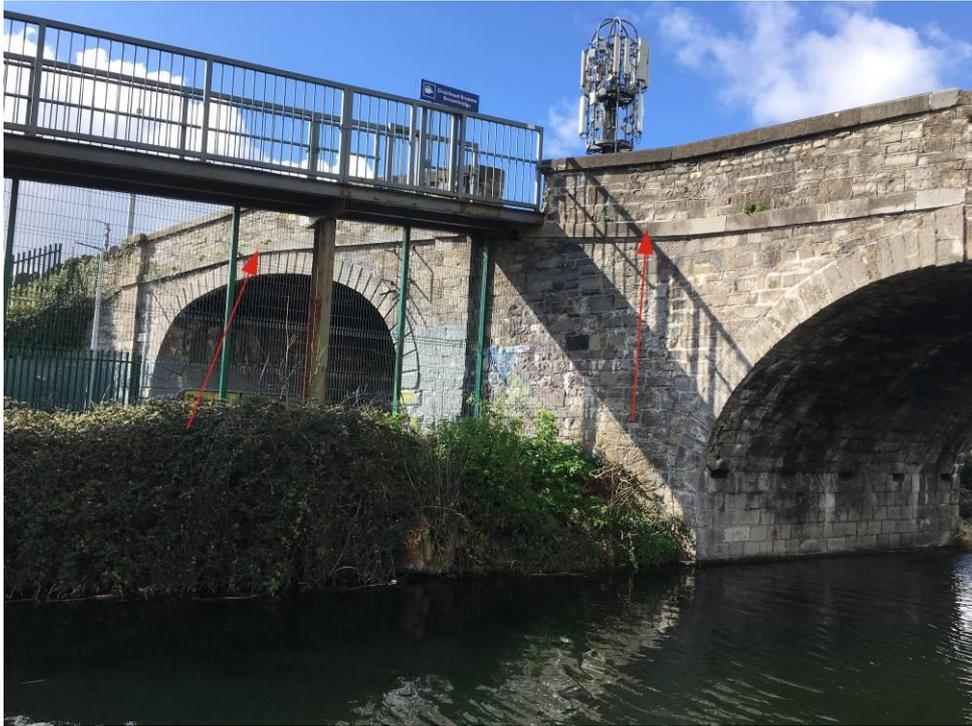
A number of finishes and construction methods were assessed during the design process. Initially the preferred option was to re-use the original facing stone but it became clear that this would not be successful due to the technical constraints of the new construction. The string course is an essential element of the existing composition but the increased height of the arch would distort its connection to the string over the canal. The precast arch construction would reduce the existing voussoirs to cladding stones and the facing stone of the spandrels would also become cladding stones tied back to the concrete structure behind. The combination of all these factors makes it very difficult to design or build stonework that would sit well alongside the original fabric and there were concerns that it would very much read as modern stone cladding.

Figure 25 - Image of existing spans with string course highlighted.

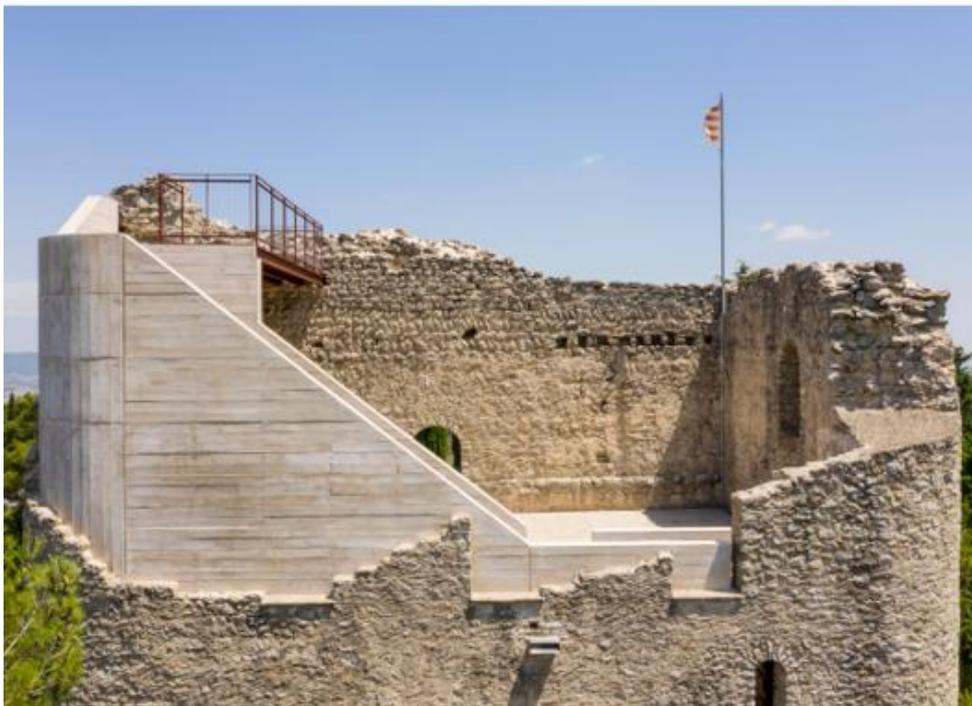
The use of a weathered steel facade was also explored as this material would tie together the rebuilt bridge and new pedestrian bridges on each side. After careful assessment it was decided to proceed with a concrete structure as this has the potential to sit most comfortably with the remaining original stonework. It is proposed to use a board marked concrete finish on all faces and to select a concrete colour that best complements the original stonework.

Figure 26 – Example of a new board marked concrete insertion in an existing stone structure.

The colour and texture of the concrete finish, along with the quality of the detailing and workmanship is critical to its success. There are many examples of fine concrete work next to historic stonework across

Europe, as identified in the image above. The design team is aware that Irish conditions are generally a lot damper than elsewhere, therefore the texture and finish of the concrete will be designed to minimise algae and vegetation growth. The texture created by the board will be controlled to ensure there are no large shelves for vegetation to take root and the surface finish will be carefully specified to limit the number of bugholes present on the finished concrete. It is proposed to use hand sawn boards to provide a finish that is not too uniform. Research into materials and sample panels will be essential prior to construction to ensure the new concrete finish complements the remaining stonework.

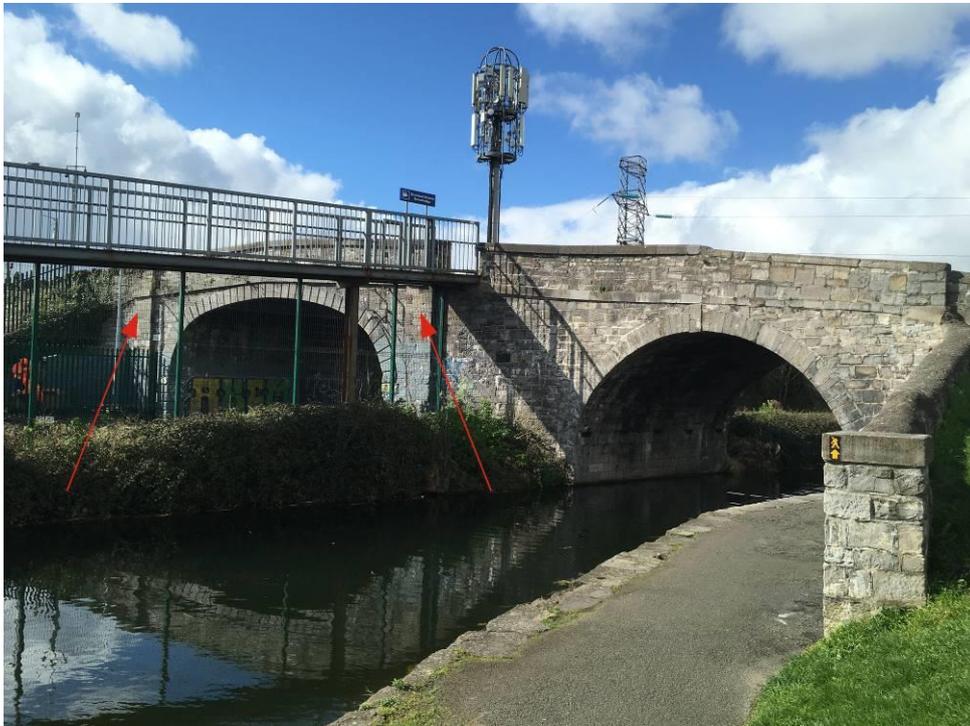
The junctions between old and new will need to be carefully considered during detail design. The presence of the piers on either side of the arch allows the new build to be contained neatly at a natural break. These junctions will still need to be skilfully detailed and executed to ensure the concrete and stonework sit comfortably together. There will be a considerable amount of stone repair and repointing on the piers following the removal of concrete shuttering. These repairs will need to be carried out with great care by a skilled stonemason.

Figure 27 – Existing bridge with engaged piers highlighted.

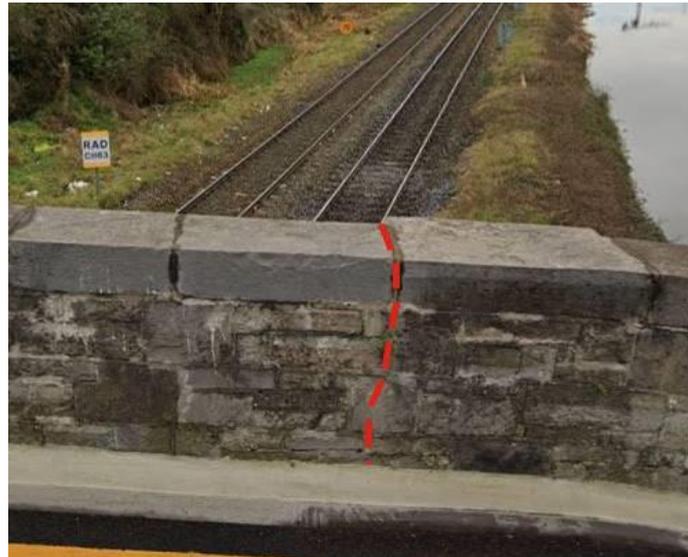
The new concrete parapets will extend up to the height of the original with the additional height provided by the contemporary design discussed below. The original parapet thickness will be carefully designed to ensure the new parapet sits in as neatly as possible with the original. The piers extend up through the parapet externally providing a natural break but there is no detail on the internal face. This creates a challenge that will need to be overcome with careful detailing and skilled craftspeople.

Figure 28 – Image of parapet internally with line highlighting where the junction with the new concrete parapet will be.

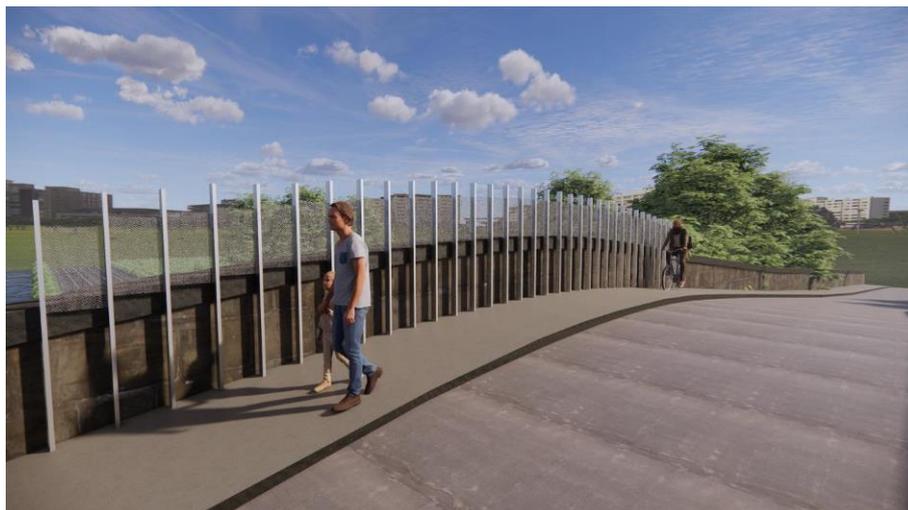
It is a safety requirement that the parapets are a minimum of 1800mm high, with the bottom 1200mm solid in the area of the OHLE. This presents a significant challenge for Broome Bridge and all of the historic bridges along the line, as the existing original parapet heights are lower than 1200mm. A rigorous design process has taken place to identify a solution that will complement the historic setting and maintain a visual connection to the rail lines and surrounding landscape, when on the bridge. It is also essential that the parapet is not the dominant feature while viewing the bridge from the canal. The proposed design is a contemporary, adaptable solution that can be implemented throughout, bringing a degree of uniformity to all interventions along the railway. An alternative option with the extended parapet structure fixed on top of the coping, was also assessed. Due to wind loads and the uncertain structural integrity of the parapets, a considerable amount of damage to the original fabric would be required to anchor the new structure through the existing parapet to new concrete pads below.

For Broome Bridge it is proposed to provide a solid metal panel from the top of the parapet up to 1200mm with an expanded metal mesh to continue up to 1800mm. The vertical supports and mesh will be carefully designed to ensure the internal face of the parapet is not obscured and that the mesh allows a good visual connection to the surroundings.

Figure 29 – Render of design proposal to increase the parapet height to 1800mm with mesh about 1200mm.

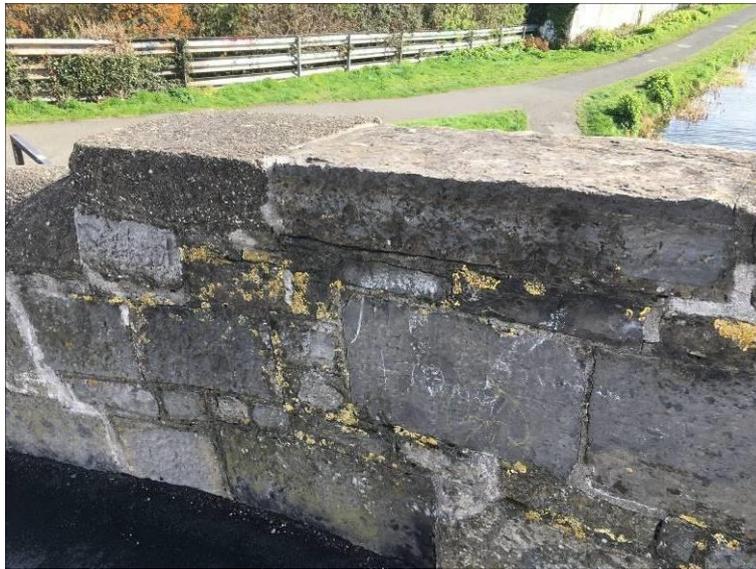
Figure 30 – Existing parapet requires repair and conservation works.

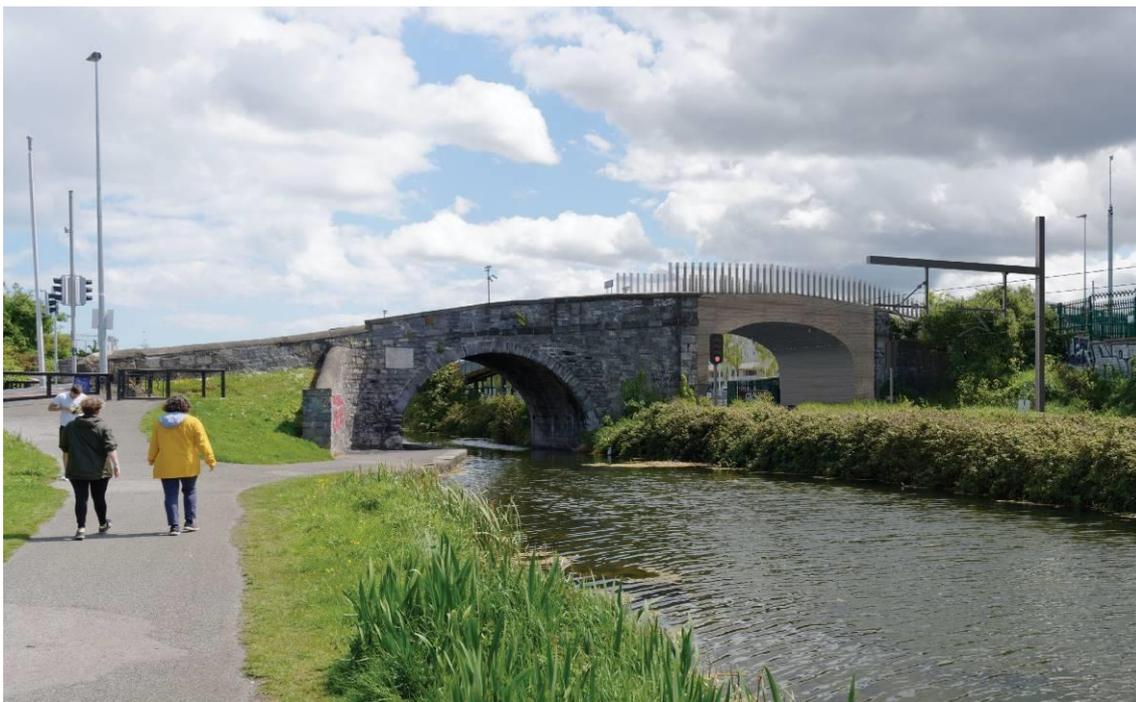
Figure 31 – Render of proposal on completion – West Side.
