**Appendix A21.6
Castleknock Bridge -
Architectural Heritage
Impact Assessment**

DART+ West

Proposed works at Castleknock Bridge,
Castleknock, Co. Dublin

Architectural Heritage Impact Assessment

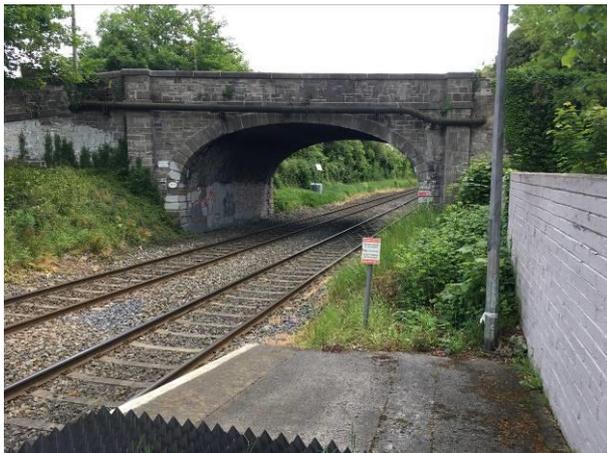
Figure 1 – West elevation of Castleknock Bridge over the railway line.

Castleknock Bridge has a single elliptical arch and is bookended with engaged piers north and south. The bridge is primarily constructed with squared limestone, laid in courses. The station platforms extend nearby to the west, but do not touch the bridge. The aforementioned difference in angle is corrected by the bridge which itself is built at an angle. This is reflected in its skewed arch construction, visible in the masonry of the vault.

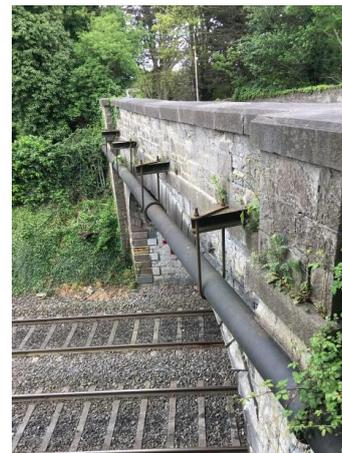
Figure 2 – East elevation of Castleknock Bridge, access restricted.

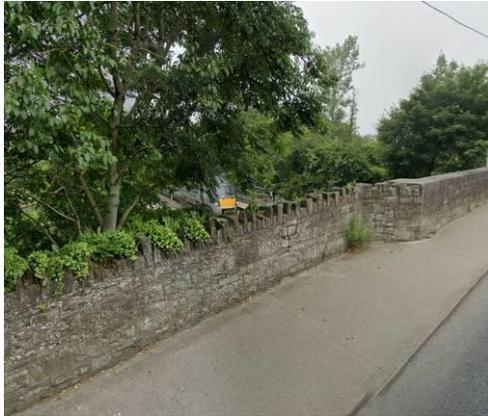
Figure 3 – West parapet ending with pier and historic boundary wall abutting.

On the south side the bridge ends with the piers before meeting the historic boundary walls to the south, on either side of the road. On the west side the boundary wall is historic and comprises a large buttressed retaining wall upholding the road, as it rises to bridge level. It is built of limestone rubble and capped with vertical limestone slabs in the style of 'cow and calf'. On the east side, the boundary wall is shorter in length and continues on as a timber fence. The east side seems to have been recently re-built in a similar traditional style.

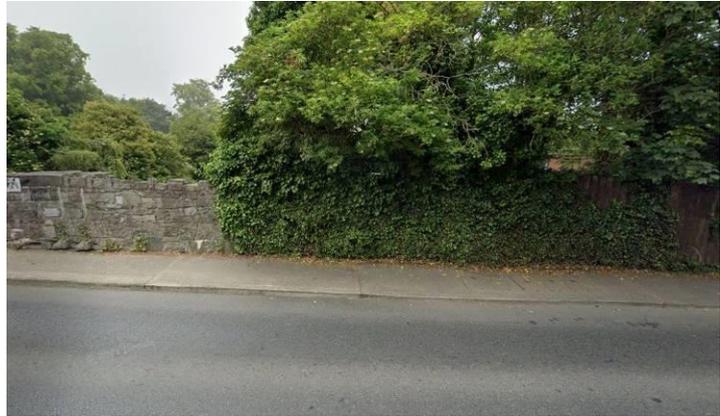
Figure 4 – Junction between pier and boundary wall on left side of image. Ivy growth covering modern fencing.

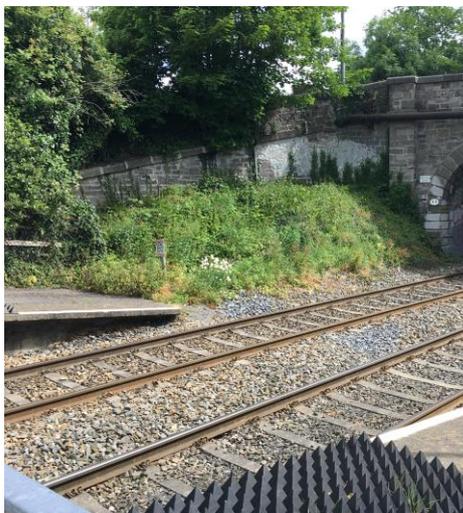
Figure 5 – North west wing wall.

On the north side, the bridge has two wing walls, one either side which curve away in the direction of the railway line. The north west wing wall runs alongside a ramp to the train station and is faced with squared limestone rubble, laid in courses. The copings are large limestone blocks. The outer face of north east wing parapet, facing the railway line, has been largely rebuilt in blockwork.

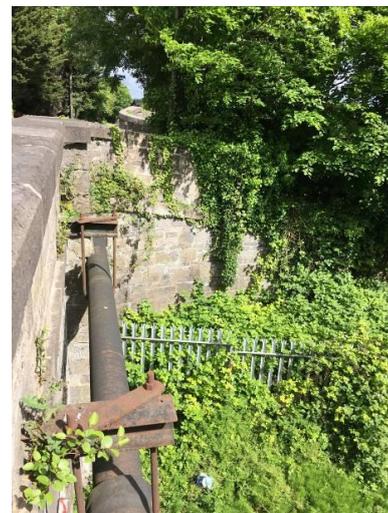
Figure 6 – North east wing wall with substantial block repairs.

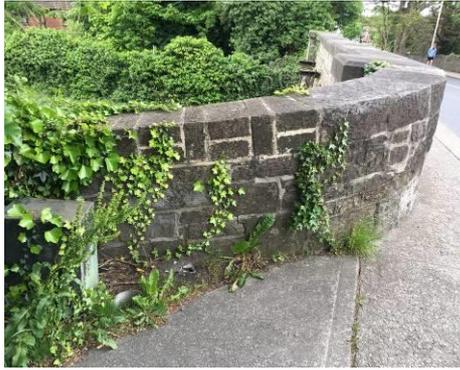
Figure 7 – North east parapet with modern blockwork.

The north east parapet wall curves away and slopes down alongside a set of steps which give access to the Royal Canal Way. The copings are of modern blockwork on the curve.

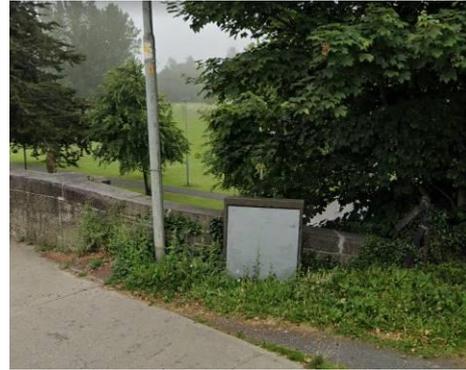
Figure 8 – North west parapet.

A service pipe travels alongside the external face of the bridge on both elevations. The pipe travels above the crown of the arch, supported by small I beams fixed back to masonry on the west and east faces. On both elevations the pipe penetrates the masonry of the wing walls to the north. On the west face the pipe also penetrates the historic boundary wall to the south as it changes direction.

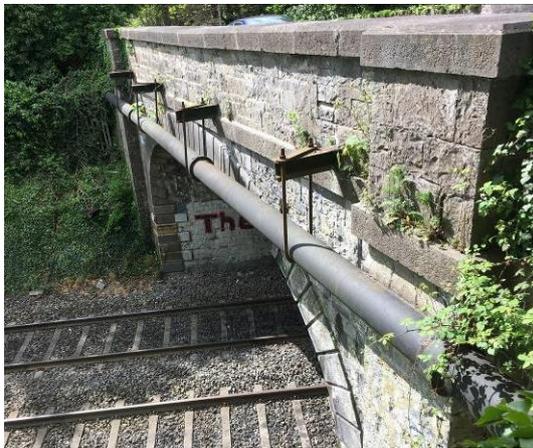
Figure 9 – Canal spandrel with squared limestone.

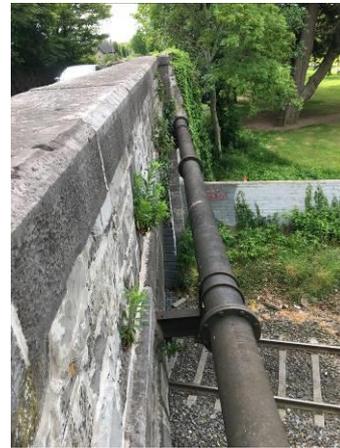
Figure 10 –West spandrel of bridge and canal arch.

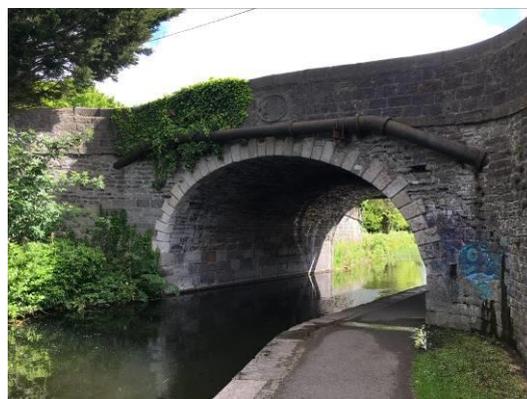
Figure 11 –Granard Bridge west elevation.

The nearby Granard Bridge spans over the canal and also has an elliptical arch. Its towpath runs to the south, and on its western side, a ramp provides access to the train station. On its eastern side a footpath provides access to the towpath and the Royal Canal Way. It is built of a mixture of rubble and squared limestone of varying sizes brought to courses in parts and laid randomly in others. It has a single arch with a continuous string course and parapet across a hump-back form.

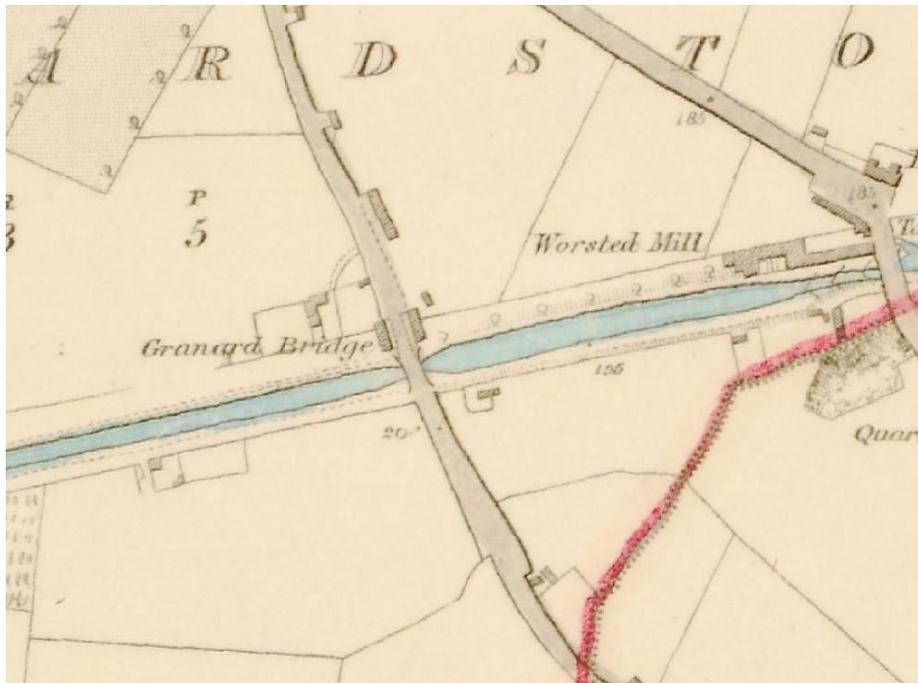
Figure 22 – Extract from 6inch OSI Map 1829 - 1841 showing Granard Bridge crossing the Royal Canal.

The bridges as portrayed in available historic maps generally align with construction dates of c.1790-1820 and its later extension in c.1846. In the 6inch OS Map, the railway line has not yet been constructed. Two small structures are recorded either side of Granard Bridge to the north where it meets land. The canal is shown narrowing as it passes below the bridge and an informal path is marked along the north of the canal.

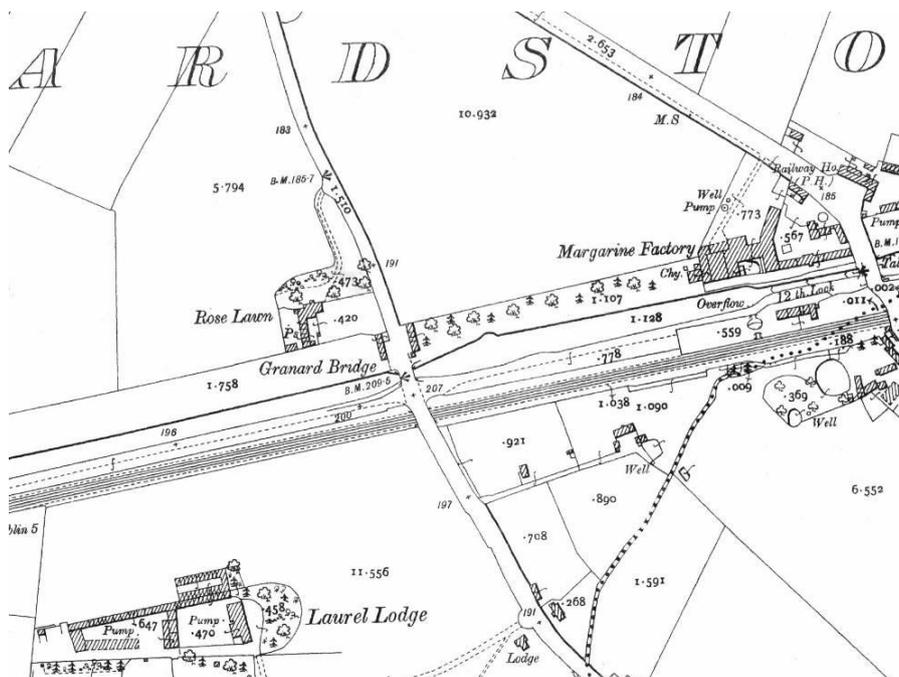
Figure 13 - 25inch OSI Map 1888-1913 showing the addition of the rail line and bridge.

The 25inch OSI Map records the arrival of the railway line. A new bridge appears over the railway line, and a slight change in direction is shown due to the differing road angles either side. The towpath along the south of the canal remains and Laurel Lodge is now shown to the south west.

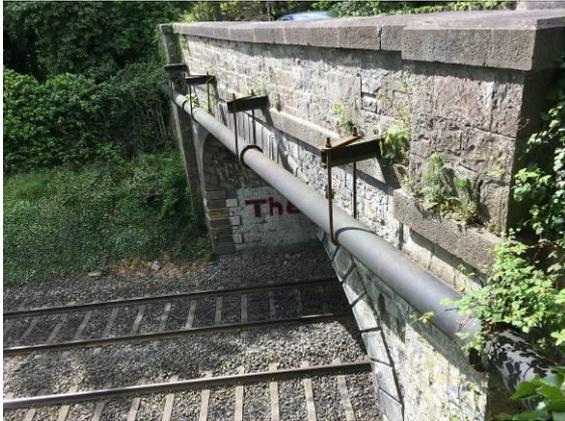
Figure 14 – Painting and graffiti under the bridge.

From a distance the stonework of the arches, buttresses and spandrels do not appear to have major structural issues. The stonework on the face generally appears to be in good condition and has not suffered excessive weathering. The stonework forming the arch could not be inspected but it is clear that all the stone has been painted at low level, presumably to cover earlier graffiti. There appears to be a number of phases of pointing on the bridge, some of which is likely to be an inappropriate cement mortar. The pointing has been washed out or fallen away in some areas.

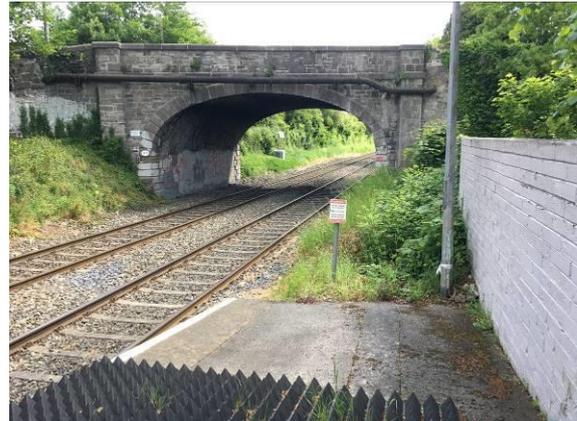
Figure 15 – West elevation of bridge.

There are two wing walls of varying condition on the north side of the bridge. The wall to the north west is covered with extensive vegetation on the road side. The vegetation extends down over the parapet to the rail side. A large service pipe runs along the face of the bridge and penetrates the wing wall causing significant stone disturbance. A substantial amount of rebuilding has taken place, particularly below the pipe. This has been poorly carried out and does not match the original stone pattern. The string course has also been altered creating an odd junction where different string thicknesses meet. A lot of the internal face of the wall appears to be painted below the string course and ivy growth is starting to take hold near the base of the wall. The east face also has a service pipe fixed to the external face but it is not possible to see the extent of disturbance caused where the pipe penetrates the north east wing wall. The parapet of this wall has been substantially rebuilt with blockwork, particularly on the internal face. It is difficult to determine the extent of blockwork on the wing parapet due to the extent of vegetation growth. The copings on this section of wall have also been replaced with blockwork and there are a number of cracks in the joints. It was not possible to assess the pointing on the wing walls due to access limitations but it appears to be in a similar condition to the adjoining spandrels and piers.

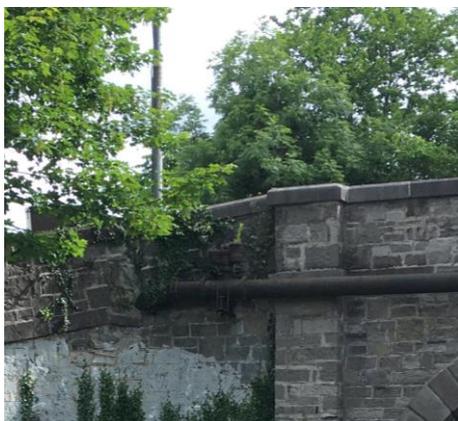
Figure 16 – Poorly rebuilt stonework around service pipe on north west side.

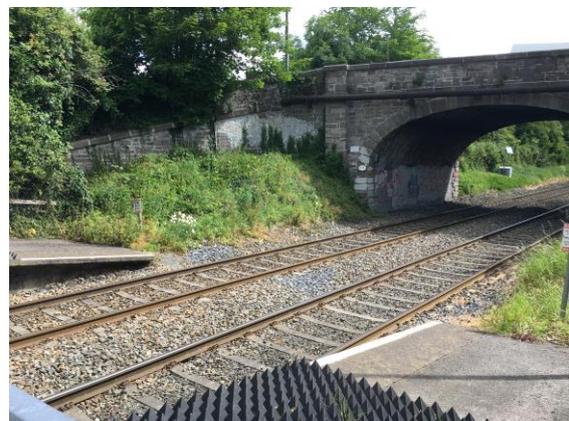
Figure 17 – Vegetation and paint on north west wing wall and paint under bridge.

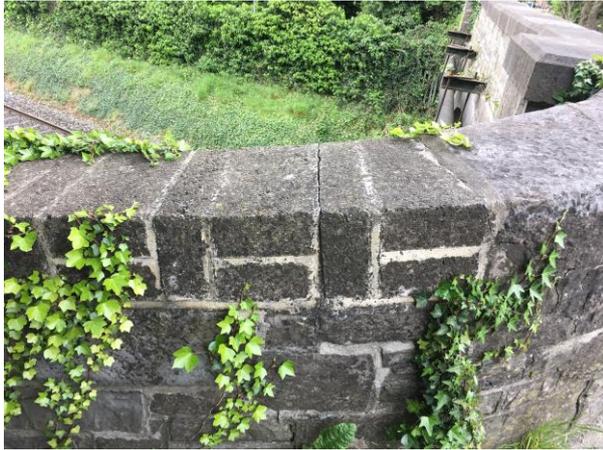
Figure 18 – North east parapet repaired in blockwork with cracks visible.

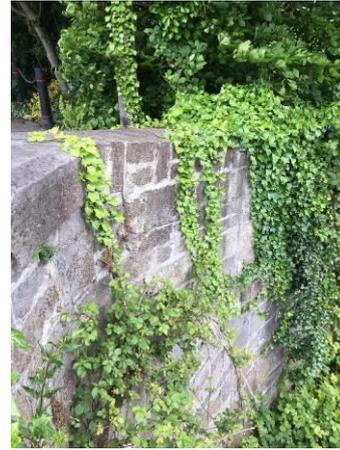
Figure 19 – North east wing wall parapet rebuilt in blockwork internally.

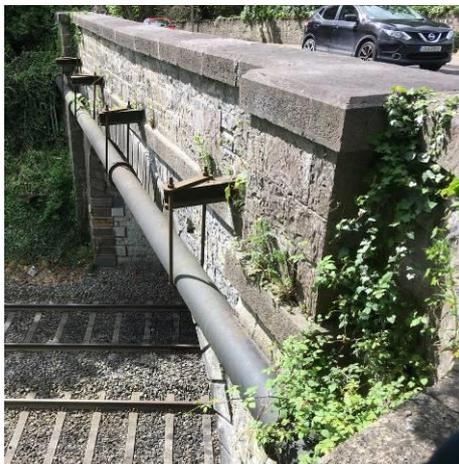
Figure 20 – East parapet with steel beams built in to historic stonework.

The parapet stonework appears to be in fair condition but it is not possible to properly inspect the external faces. It is clear that substantial disturbance has occurred on the external face of both parapets where steel beams have been built in to support the service pipes. The joints have been strap pointed in areas in what appears to be a hard cement mortar. Some flush pointing has also been carried out more recently where vegetation was removed. There is evidence of shrinkage cracks between the stonework and mortar on the internal faces. There is also evidence of mortar joints breaking away from the coping stone in a number of areas potentially due to movement of the coping. The coping stones have been repaired in isolated areas where original stone has been lost. These repairs have been poorly carried out in mortar and are likely to fail quite quickly. The base of the parapet is visible on the south east internal face where the road has been lowered. This important stonework appears to be stable, but it would benefit from pointing works to reduce the likelihood of unravelling in future.

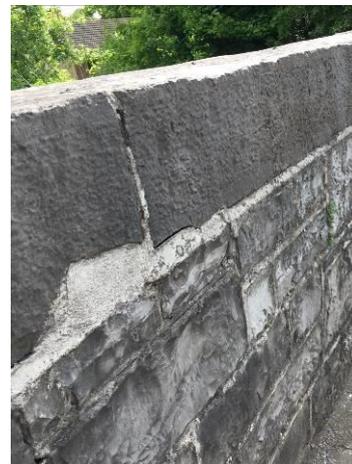
Figure 21 – Joint below coping stones broken.

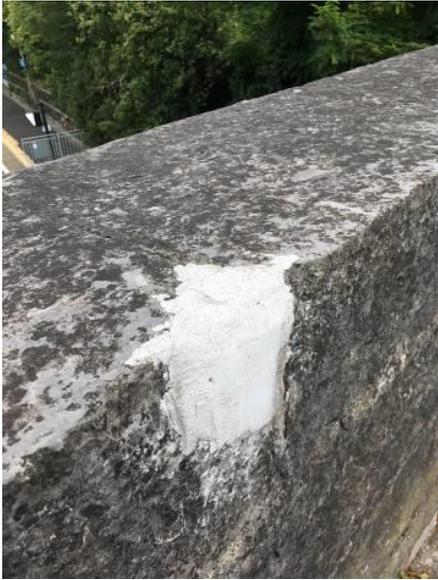
Figure 22 – Poor mortar repairs to copings.

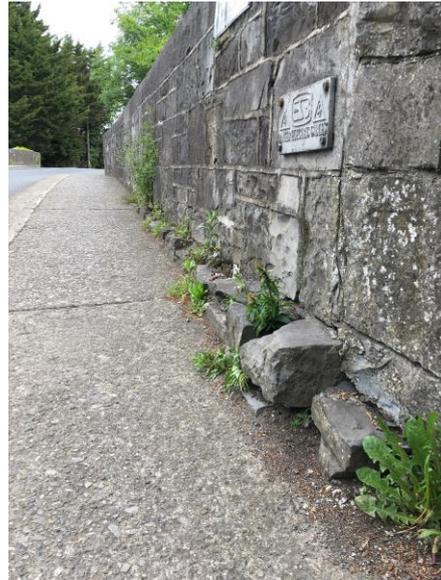
Figure 23 – Stonework at base of wall requiring pointing.

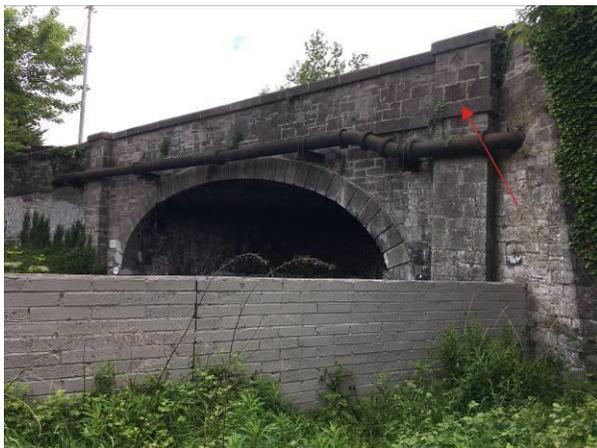
Figure 24 – West elevation with string course highlighted.

A number of finishes and construction methods were assessed during the design process. Initially the preferred option was to re-use the original facing stone but it became clear that this would not be successful due to the technical constraints of the new construction. The string course is an essential element of the existing composition but the increased height of the arch would distort its connection to the string course on the piers. The precast arch construction would reduce the existing voussoirs to cladding stones and the facing stone of the spandrels would also become cladding stones tied back to the concrete structure behind. The combination of all these factors made it very difficult to design or build stonework that would sit well alongside the original fabric and there were concerns that it would very much read as modern stone cladding.

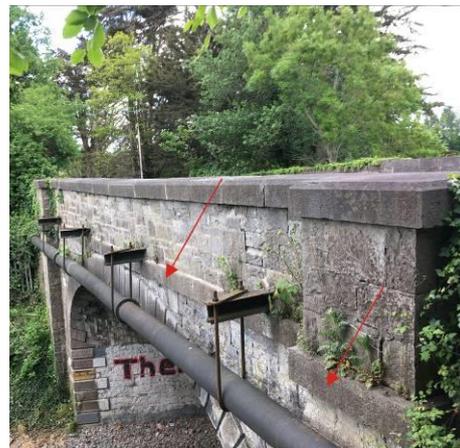
Figure 25 – East Elevation with string course highlighted.

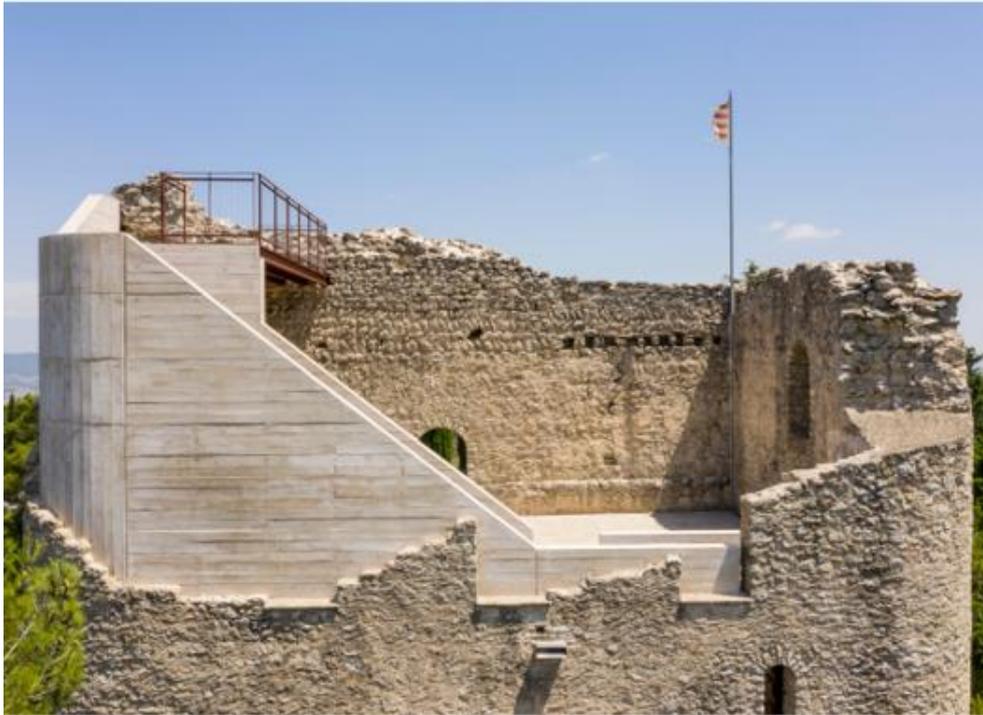
Figure 26 - Example of a new board marked concrete insertion in an existing stone structure.

structure as this has the potential to sit most comfortably with the remaining original stonework. It is proposed to use a board marked concrete finish on all faces and to select a concrete colour that best complements the original stonework.

The colour and texture of the concrete finish, along with the quality of the detailing and workmanship is critical to its success. There are many examples of fine concrete work next to historic stonework across Europe, as identified in the image above. The design team is aware that Irish conditions are generally a lot damper than elsewhere, therefore the texture and finish of the concrete will be designed to minimise algae and vegetation growth. The texture created by the board will be controlled to ensure there are no large shelves for vegetation to take root and the surface finish will be carefully specified to limit the number of bugholes present on the finished concrete. It is proposed to use hand sawn boards to provide a finish that is not too uniform. Research into materials and sample panels will be essential prior to construction to ensure the new concrete finish complements the remaining historic stonework.

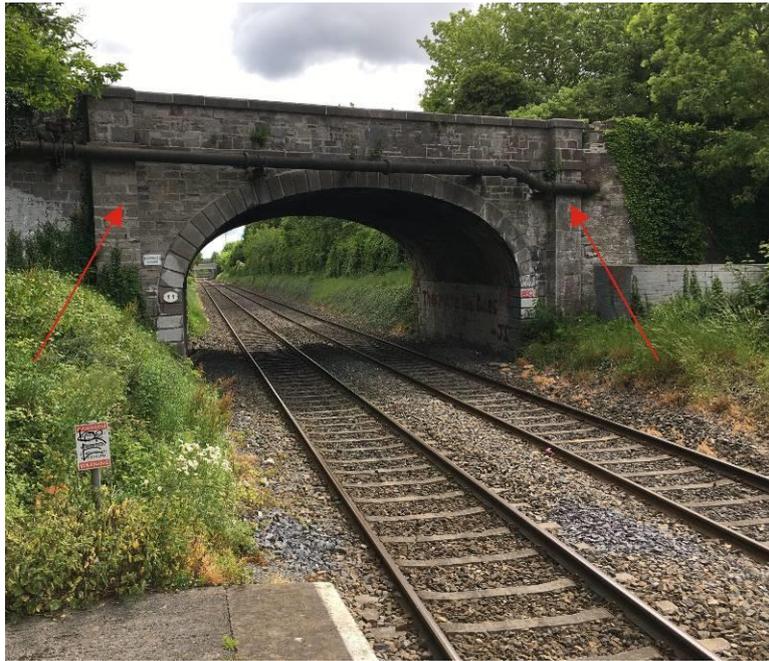
Figure 27 - East elevation with piers highlighted.

The junctions between old and new will need to be carefully considered during detail design. The presence of the piers on either side of the arch allows the new build to be contained neatly at a natural break. These junctions will still need to be skilfully detailed and executed to ensure the concrete and stonework sit comfortably together. There will be a considerable amount of stone repair and repointing on the piers following the removal of concrete shuttering. These repairs will need to be carried out with great care by a skilled stonemason.

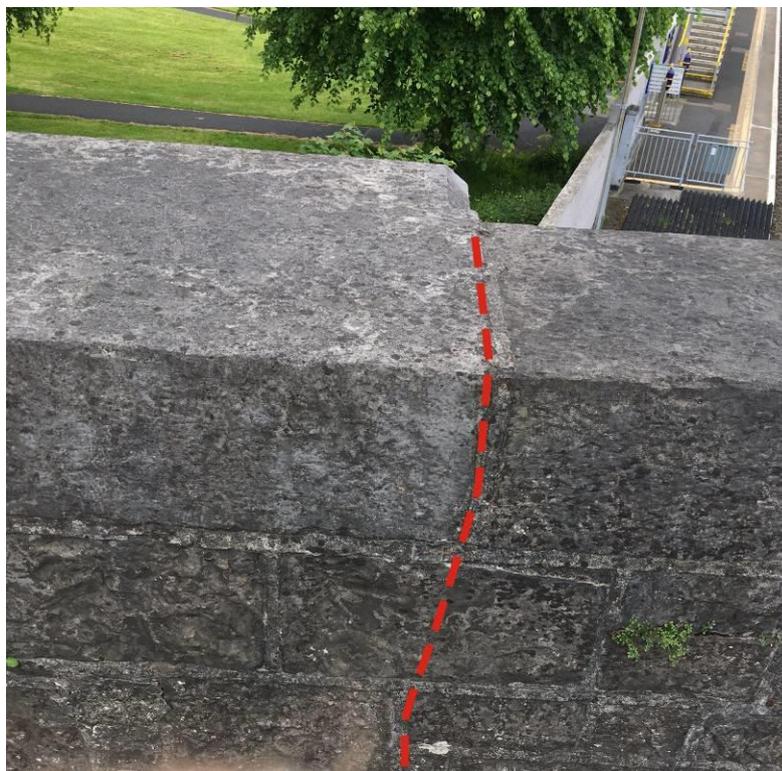
Figure 28 - Image of parapet internally with line highlighting where the junction with the new concrete parapet will be.

The new concrete parapets will extend up to the height of the original with the additional height provided by the contemporary design discussed below. The original parapet thickness will be carefully designed to ensure the new parapet sits in as neatly as possible with the original. The piers extend up through the parapet externally providing a natural break but there is no detail on the internal face. This creates a challenge that will need to be overcome with careful detailing and skilled craftspeople.

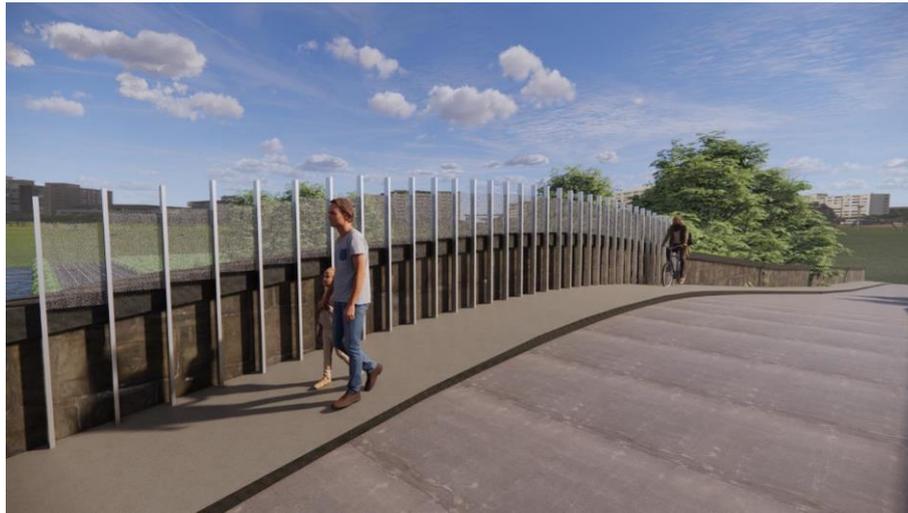
Figure 29 – Render of design proposal to increase the parapet height to 1800mm with mesh about 1200mm.

For Castleknock Bridge it is proposed to provide a solid metal panel from the top of the parapet up to 1200mm with an expanded metal mesh to continue up to 1800mm. The vertical supports and mesh will be carefully designed to ensure the internal face of the parapet is not obscured and that the mesh allows a good visual connection to the surroundings.
