Appendix 14.1 Baseline Noise & Vibration Surveys

A.1. Baseline Noise and Vibration Surveys

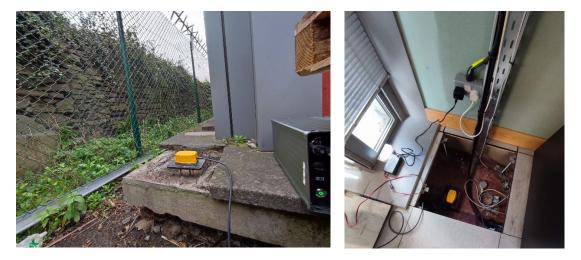
Con Colbert house contains a computer data centre on the first floor of the westernmost block. Measurements were taken on a plinth at the north-western corner of the building and on the concrete floor in the server room. The computer servers are mounted directly onto this floor. Figure A14-2 shows the geophone installation prior to the deployment of the sandbags.

Figure A14-2 Con Colbert House Installation (External (left) and Server Room (right)).

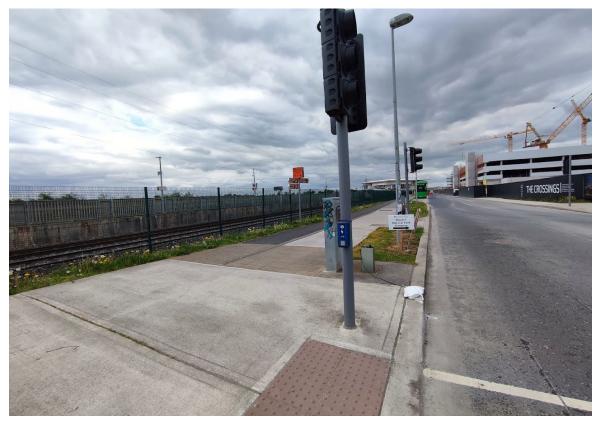
Three VMTs were deployed at Adamstown at distances of 10m, 20m and 40m from the railway. Figure A14-3 shows the geophone installation at 10 m with the sandbag deployed. The purpose of having three VMTs in an array simultaneously was to determine the horizontal attenuation of vibration levels.

Figure A14-3 Adamstown 10m Installation

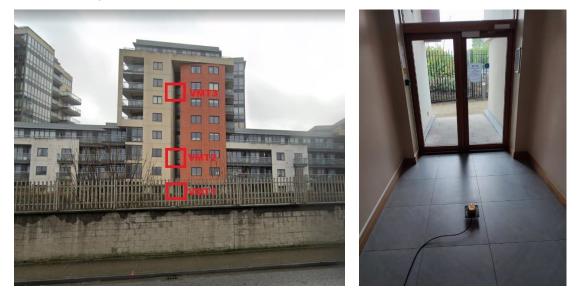
Kilmainham Square is a high rise apartment complex immediately adjacent to the railway. Simultaneous vibration measurements were taken on three floors of the building to evaluate the potential for building resonances occurring and amplification of the vibration with height. Figure A14-4 shows the location of the measurement locations and the geophone installation prior to the deployment of the sandbag.

Figure A14-4 Kilmainham Square Installation
